LONGMONT

1881-2006 **BRICK**

MICHAEL SHERNICK
INTRODUCTION TO BUILDING MATERIALS AND METHODS
ARCH 5310
PROFESSOR ERIC MORRIS
UNIVERSITY OF COLORADO AT DENVER
NOVEMBER 21, 2006

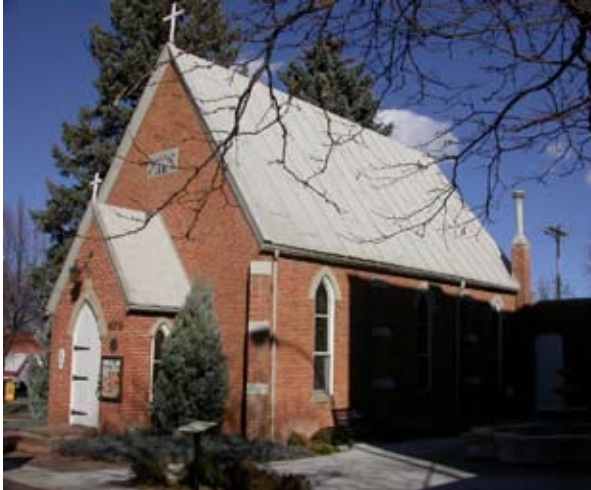
**ST. STEPHEN'S CHURCH
470 MAIN STREET
1881**

THE OLDEST SURVIVING CHURCH IN LONGMONT, ST. STEPHEN'S HAS BEEN THROUGH MULTIPLE RENOVATIONS AND CHANGES, AS EVIDENCED BY THE VARIETY OF BRICK TECHNIQUES USED. EVEN SO, THE BUILDING MAINTAINS ITS CHARACTER.

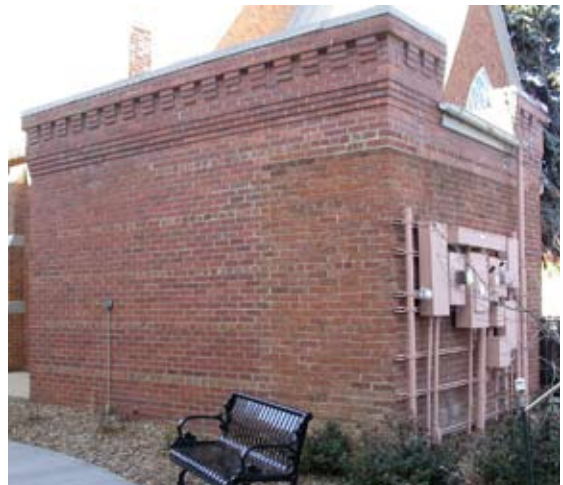
GOTHIC ARCHES ARE USED FOR MOST OF THE WINDOWS AND ENTRYWAYS. NOTE THE SEPARATION OF THE BRICK FROM THE STONE NEXT TO THE LAMP FIXTURE AND THE REPAIRED BRICKWORK AROUND THE WINDOW. ALSO NOTE THAT THE SMALLER WINDOWS USE STONE FOR THEIR ARCHES WHEREAS THE LARGE WINDOW IN THE APSE IS A ROUGH BRICK GOTHIC ARCH.

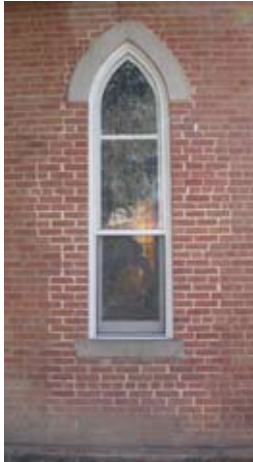
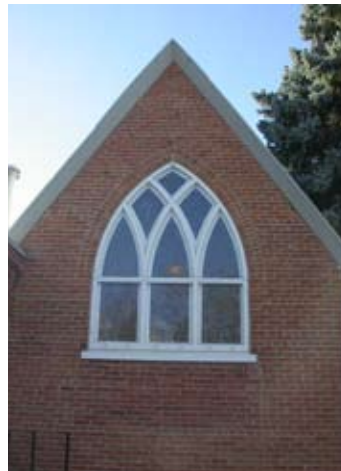
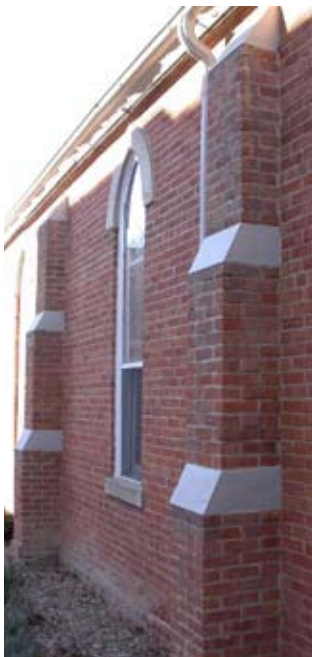
IT APPEARS THAT THE ORIGINAL ENTRYWAY WAS A GOTHIC ARCH, WHICH SUBSEQUENTLY WAS REPLACED WITH A NARTHEX EXTENDING FROM THE MAIN FACADE. NOTE, TOO, THAT ON THE FACADE, THE BRICK IS LAID IN RUNNING BOND INSTEAD OF AMERICAN BOND AS ELSEWHERE IN THE BUILDING.

IN SPEAKING WITH CLAIRE LANIER, THE DIRECTOR OF THE ST. VRAIN HISTORICAL SOCIETY (THE OWNERS OF THE CHURCH), SHE BELIEVES THE BUILDING TO BE WOOD FRAMING WITH A BRICK VENEER EXTERIOR. IF THIS IS THE CASE, THEN THESE BUTTRESSES ARE POSSIBLY MORE ORNAMENTAL THAN STRUCTURAL.

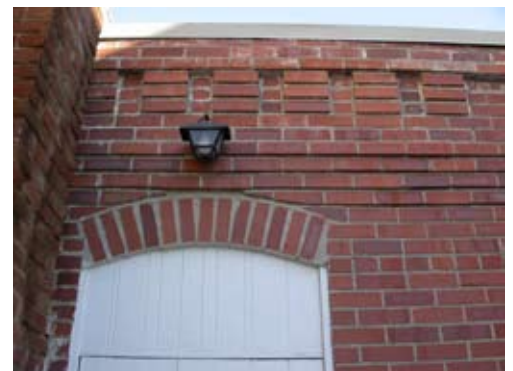
THIS ROUGH ELLIPTICAL ARCH ON THE ADDITION IS OUT OF CHARACTER WITH THE REST OF THE BUILDING.

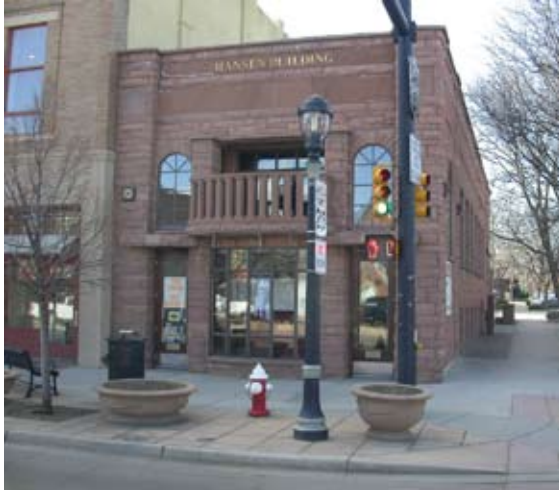
**HANSEN BUILDING
477 MAIN STREET
1904**

THE HANSEN BUILDING, ORIGINALLY BUILT FOR \$50,000, WAS ORIGINALLY RENOVATED IN 1962, THEN AGAIN IN 1997 BY JIM AND SANDY HANSEN FOR \$950,000. IT IS AN EXCELLENT EXAMPLE OF THE STYLE COMMON IN LONGMONT OF COMBINING LYONS RED SANDSTONE WITH BRICK.

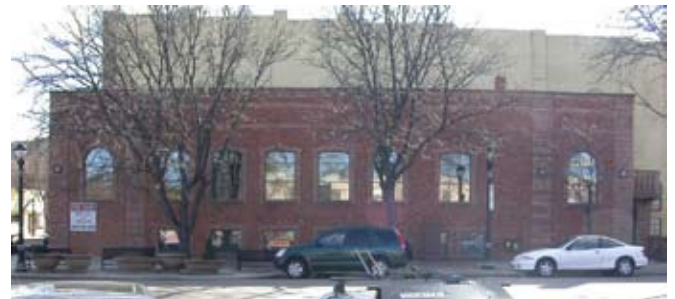
THE COMBINATION OF BRICK AND SANDSTONE CREATES A SUBTLE VARIATION OF COLOR ALONG THE NORTH FACADE.

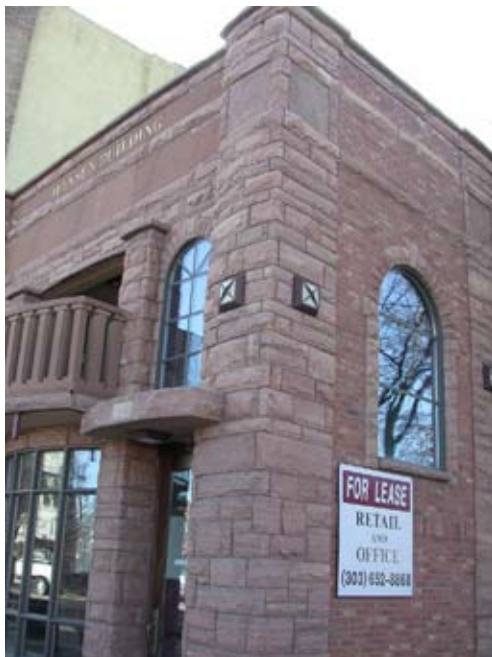
NOTE THE USE OF RUSTICATED SANDSTONE IN RELATIONSHIP TO THE RED BRICK, WHICH IS LAID IN RUNNING BOND WITH CONCAVE MORTAR JOINTS. THE SANDSTONE HAS ALSO BEEN USED ON FACE FOR LARGE SMOOTH AREAS AND CUT TO SPECIFIC SHAPES FOR THE BALCONIES. ALL OF THE WINDOWS HAVE ROMAN ARCHES.

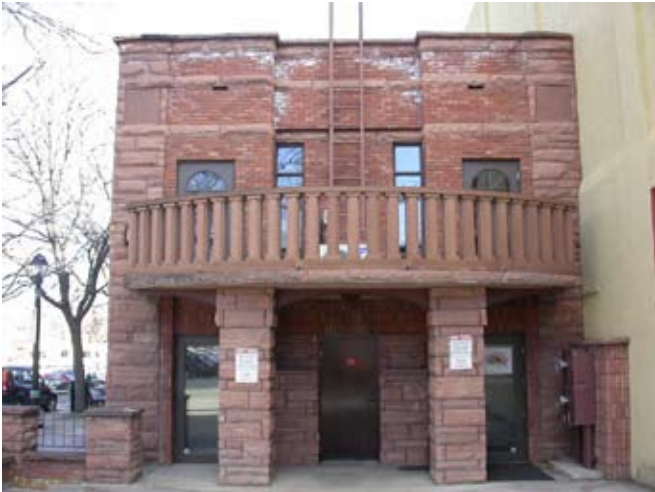
THE WEST FACADE HAS SIGNIFICANT EFFLORESCENCE PROBLEMS NEAR THE CORNICE. THE EFFLORESCENCE IS MOSTLY PRESENT WITH THE BRICKWORK, BUT SOME OF THE SANDSTONE MORTAR JOINTS ARE ALSO AFFECTED.

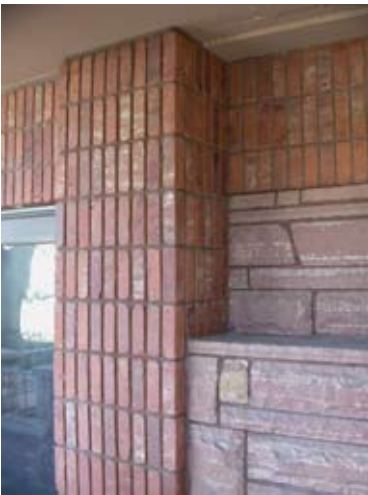
DETAILS FROM THE NORTH FACADE INCLUDE BANDS OF SANDSTONE, THREE SOLDIER BRICKS FOR A VENT, AND A SOLDIER COURSE BAND. NOTE, TOO, HOW THE SECOND FLOOR WINDOW IS SET WITH A ROMAN ARCH, WHEREAS THE GARDEN LEVEL WINDOW IS SET WITH A LINTEL.

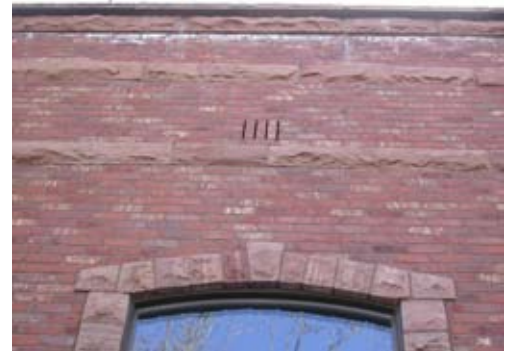
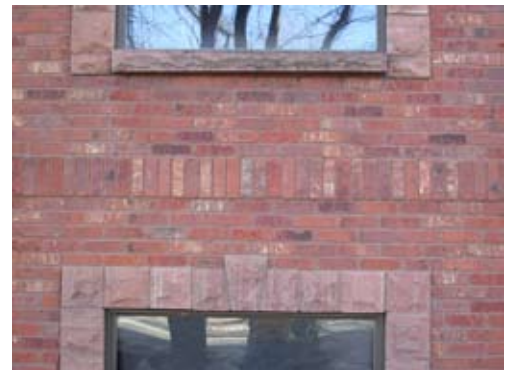
THE FIRST FLOOR OF THE WEST FACADE USES SOLDIER COURSES. THE VERTICALITY OF THE BRICK VISUALLY OFFSETS THE WEIGHT OF THE HEAVY CURVED BALCONY DIRECTLY OVERHEAD.

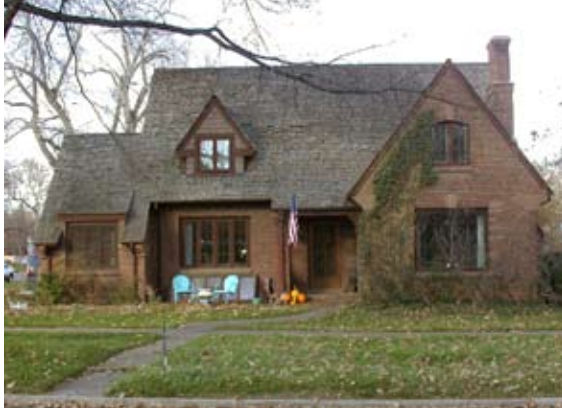
**HISTORIC LANDMARK RESIDENCE
960 5TH AVENUE
1928**

LOCATED IN LONGMONT'S HISTORIC DISTRICT, THIS RESIDENCE IS AN EXCELLENT EXAMPLE OF BRICK DETAILING IN A UNIQUE LOCAL VERNACULAR.

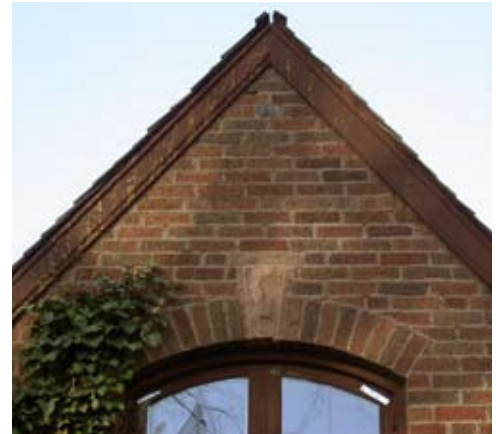
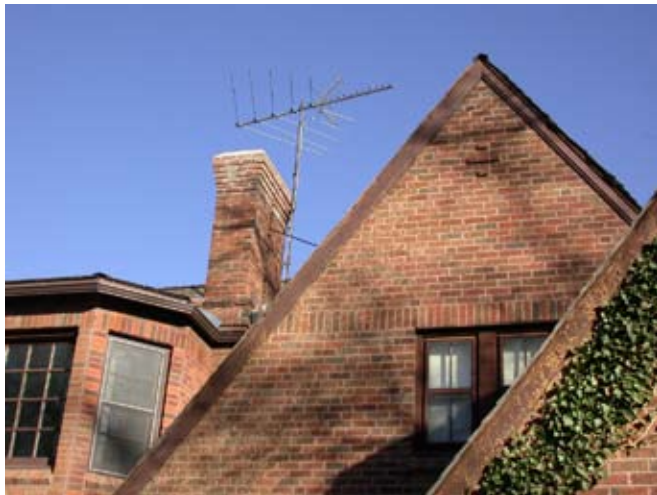
THE FACADE IS LAID IN A VARIANT OF AMERICAN BOND. EVERY SEVENTH COURSE, INSTEAD OF EVERY SIXTH, IS A HEADER COURSE. INTERESTINGLY, THE HEADER COURSES ARE LAID IN FLEMISH BOND. NOTE THE INTEGRATION OF RED SANDSTONE FOR THE KEYSTONE OF THE ROUGH PARABOLIC ARCH. SANDSTONE HAS ALSO BEEN USED AT THE CORNERS OF THE CHIMNEY AND THE GABLES AS A COUNTERPOINT TO THE CORBELLED DETAILS IN THESE AREAS. SOLDIER COURSES ARE USED TO DISTINGUISH BETWEEN FLOORS.

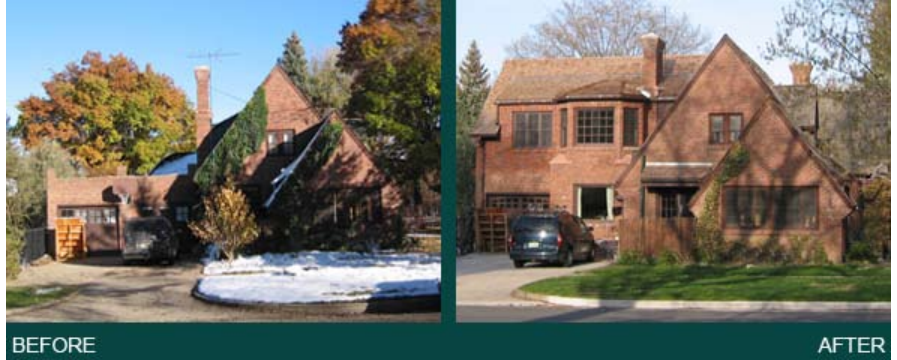
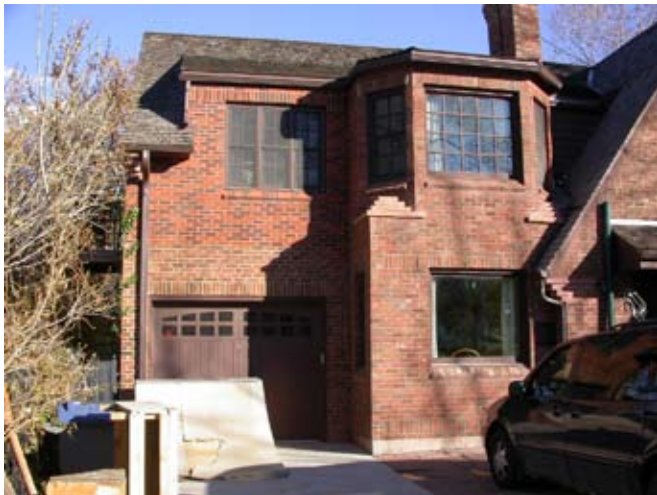
THE RENOVATION WAS SENSITIVE TO THE DETAILING OF THE ORIGINAL HOUSE: SOLDIER COURSES ARE CONTINUED, AND SANDSTONE DETAILS ARE INCORPORATED AT THE BASE OF THE BAY WINDOW.

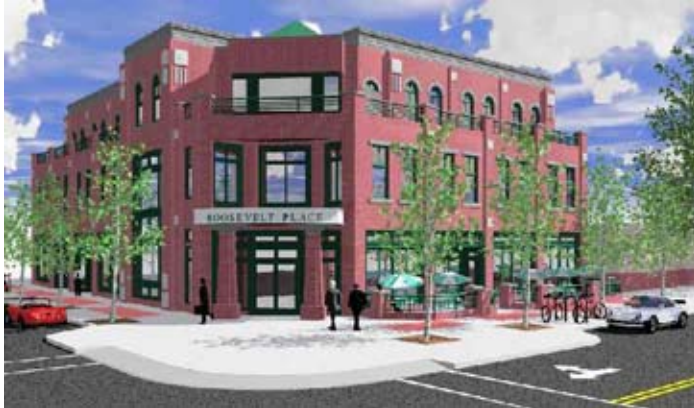
**ROOSEVELT PLACE
636 COFFMAN STREET
2002**

BUILT ON SPECULATION, ROOSEVELT PLACE IS INTENDED AS A CLASS A OFFICE/RETAIL BUILDING. IT GAINS SOME OF ITS HIGH END APPEAL FROM THE BRICKWORK, WHICH IS MORE CAREFULLY DONE THAN IN MANY CONTEMPORARY BUILDINGS.

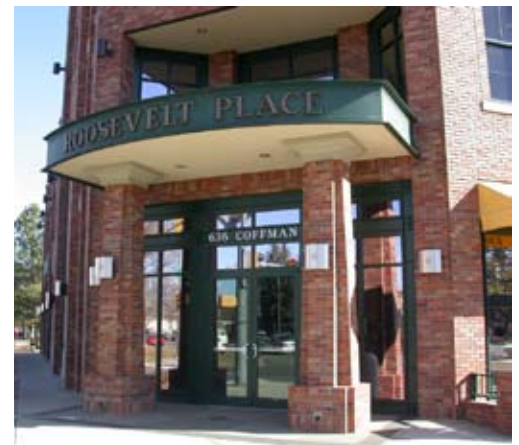
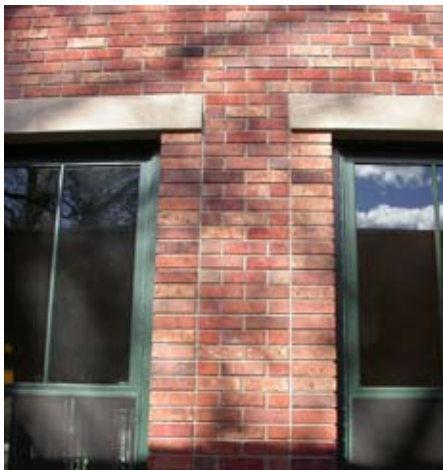
NOTE THE SLIGHTLY TAPERED BRICK COLUMNS, WHICH GIVE THE ENTRANCE A MORE GRACEFUL APPEARANCE. THE BUILDING IS MADE OF STRUCTURAL STEEL, SO THESE COLUMNS ARE PURELY FOR DECORATION.

THE LINTELS (AS WELL AS MOST OTHER NON-BRICK DETAILS) ARE CAST CONCRETE. NOTE THE EXPANSION JOINTS BEING USED AS A DESIGN ELEMENT TO FRAME THE WINDOW.

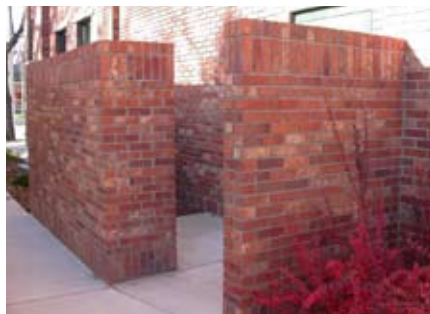
DETAILS INCLUDE SOLDIER COURSES AS WALL HEADERS WITH A ROWLOCK, ENDENTATED CORNERS WITH BRICK AND CONCRETE PILLARS, AND SANDED BRICK PAVEMENT IN THE SIDEWALK. NOTE THE EFFLORESCENCE BELOW THE METAL FENCE.

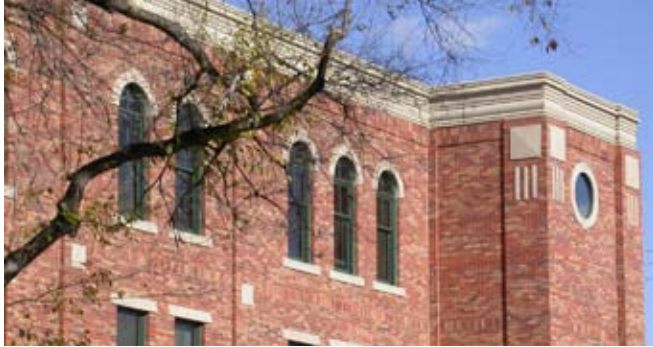
STYLES ARE MIXED: ROMAN ARCHES, GREEK TRIGLYPHS, AND A ROUND WINDOW REMINISCENT OF THE OCULUS IN THE PARTHENON. HOWEVER, SLIGHTLY CORBELLED SOLDIER COURSES AND CAREFUL USE OF EXPANSION JOINTS TO FRAME WINDOWS ADDS NEEDED DETAIL TO THE OTHERWISE PLAIN RUNNING BOND USED THROUGHOUT THE FACADE.

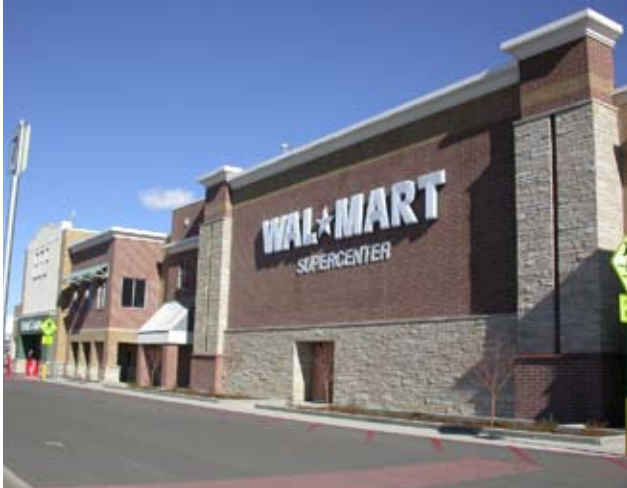
**WAL-MART SUPERCENTER
2514 MAIN STREET
2005**

BUILT AFTER MUCH CONTROVERSY, THIS WAL-MART HAS COMPLIED WITH CITY OF LONGMONT DEVELOPMENT STANDARDS FOR MASONRY IN COMMERCIAL DEVELOPMENTS.

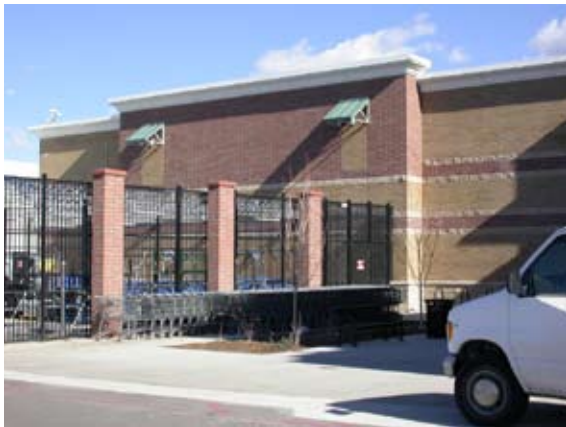
DETAILING IS LIMITED TO BANDS OF CMU AND RED AND BLOND BRICK JUXTAPOSED TO DEFINE FALSE WINDOWS. EXPANSION JOINTS ARE PLACED ONLY AS NECESSARY AND NOT USED AS A DESIGN ELEMENT. DETAILING IS KEPT TO A BARE MINIMUM, YET ATTEMPTS TO LEND AN AIR OF SOPHISTICATION TO THE BUILDING WHILE APPEARING TO BE OF THE LOCAL VERNACULAR AS WELL.

THE BUILDING IS STRUCTURAL STEEL, FILLED IN WITH CMU. THE FACADE IS A COMBINATION OF QUEEN SIZE BRICKS IN RED AND BLOND, SPLIT BLOCK CMU, STONE VENEER, AND EXTERIOR INSULATION AND FINISH SYSTEM (EIFS), ALL TIED TO THE STRUCTURAL CMU.
